**DEPARTMENT OF TRANSPORTATION**

Contract #: 04-0120F4Cty: SF/ALA Rte: 80 PM: 13.2/13.9File #: 69.28**WELDING INSPECTION REPORT****Resident Engineer:**Siegenthaler, Peter**Address:** 333 Burma Road**City:** Oakland, CA 94607**Report No:** WIR-019058**Date Inspected:** 04-Jan-2011**Project Name:** SAS Superstructure**OSM Arrival Time:** 700**Prime Contractor:** American Bridge/Fluor Enterprises, a JV**OSM Departure Time:** 1900**Contractor:** Zhenhua Port Machinery Company, Ltd (ZPMC), Changxing Island **Location:** Shanghai, China**CWI Name:** Li Yang**CWI Present:** Yes No**Inspected CWI report:** Yes No N/A**Rod Oven in Use:** Yes No N/A**Electrode to specification:** Yes No N/A**Weld Procedures Followed:** Yes No N/A**Qualified Welders:** Yes No N/A**Verified Joint Fit-up:** Yes No N/A**Approved Drawings:** Yes No N/A**Approved WPS:** Yes No N/A**Delayed / Cancelled:** Yes No N/A**Bridge No:** 34-0006**Component:** OBG Segment**Summary of Items Observed:**

OBG # BAY 4

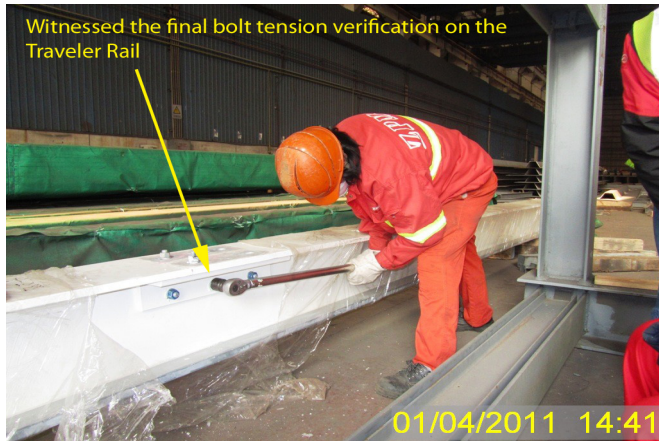
This QA Inspector witnessed the final bolt tension verification on the Traveler Rail of OBG. The torque wrench S/N was 1003153.The QA Inspector witnessed 10% of the bolts on a random basis and found the tensioning of the bolts appeared to be in general compliance with the contract specifications. The traveler rails and bolt size designations were as follows:
